Planning and Development Board

13 September 2010

**Report of the
Assistant Director (Streetscape)
and the Assistant Director
(Leisure and Community Development)**

**Old Bank House
Garden Wall and Trees**

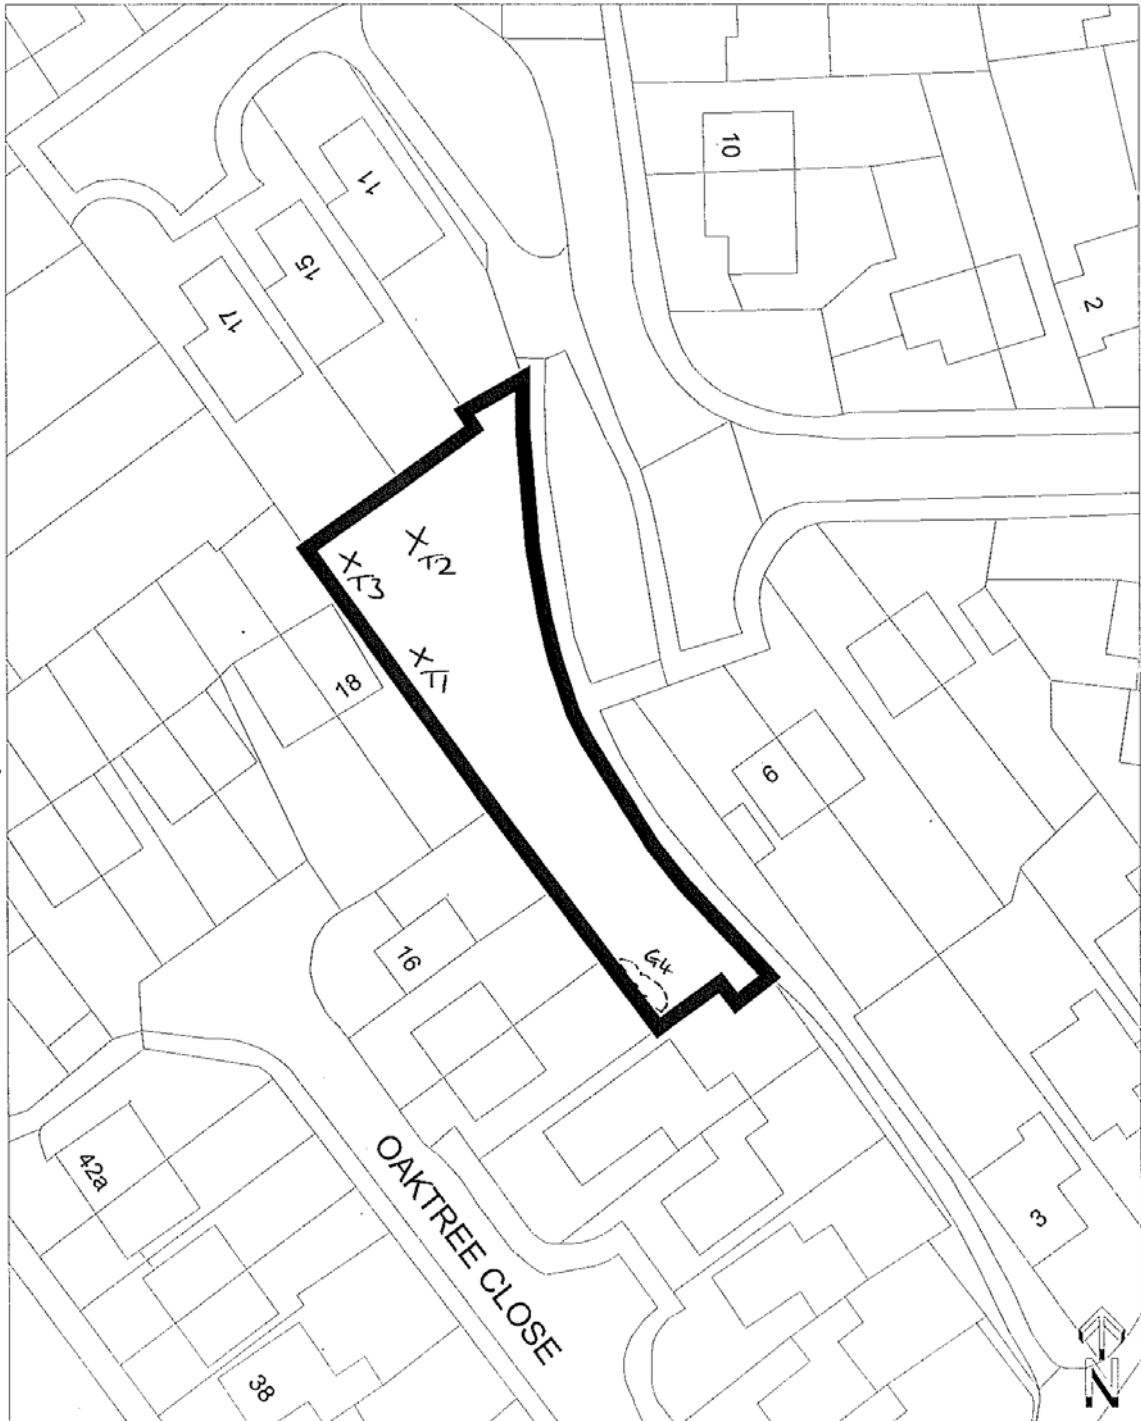
Land at Chestnut Close, Kingsbury

Date: 29/06/10
Scale: 1:500

Kingsbury	Chestnut Close	G4	Group of <i>Acer pseudoplatanus</i> (sycamore)	Small group of sycamore that are causing direct damage to adjacent boundary wall. Damage will increase unless the trees are removed.	Fell to ground level and grind stumps to below ground level
	Pear Tree Avenue	T4	<i>Sorbus aucuparia</i> (rowan)	Co-dominant stems from 0m with included bark union. Canopy appears sparse and is in terminal physiological decline. Specimen has no future potential and is liable to branch failure as the wood becomes more brittle	Fell to ground level
